Property Inspection Report

JDGAI Inspection Report: #####

INSPECTION PREPARED FOR: Sam Sample
ADDRESS: 1234 Main St.
Riverdale, MD, 20737

INSPECTOR: Sean Troxell
AGE OF PROPERTY:
DATE OF INSPECTION: 5/29/2020

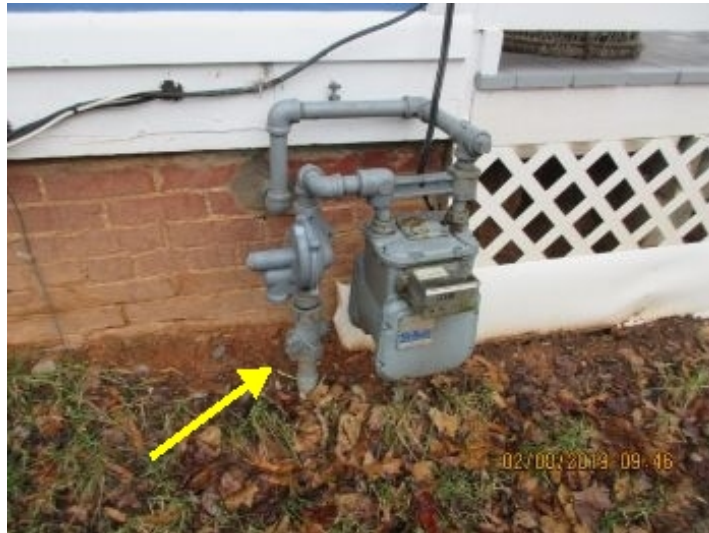
The main gas valve is located at the meter, which is located at the West Exterior.

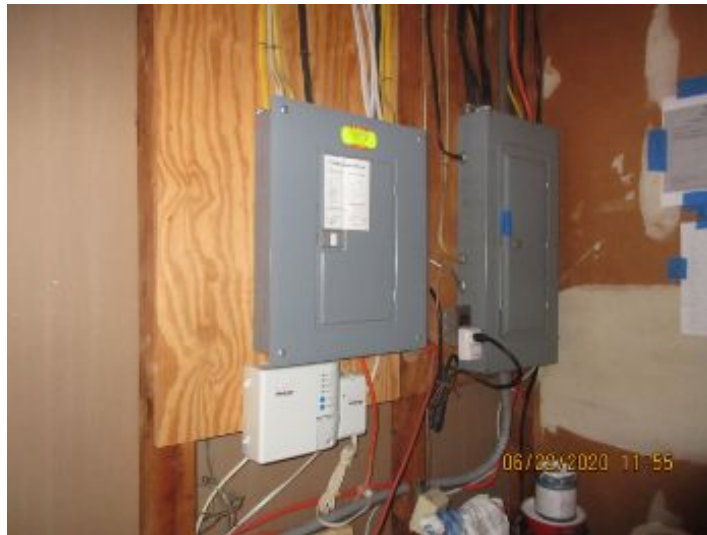
- Visible wiring appeared functional, at time of inspection.
- Original 60C distribution wiring is not compatible with modern 90C fixtures. Consult qualified electrician for review.
- Sheathing on wiring is damaged in places. Fire/Safety Issue.
- There are electrical junction box(s) present that are missing their cover plates-- Shock Hazard.

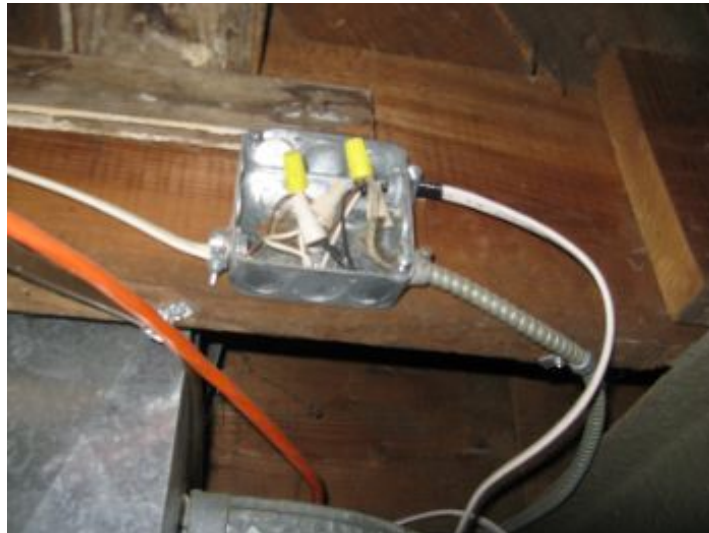
There are electrical junction box(s) present that are missing their cover plates-- Shock Hazard.
